EAU CLAIRE COUNTY Highway Department 2016 Space Needs Study

June 14, 2016
FINAL REPORT

4.3 Facility Condition Assessment Process & Audit

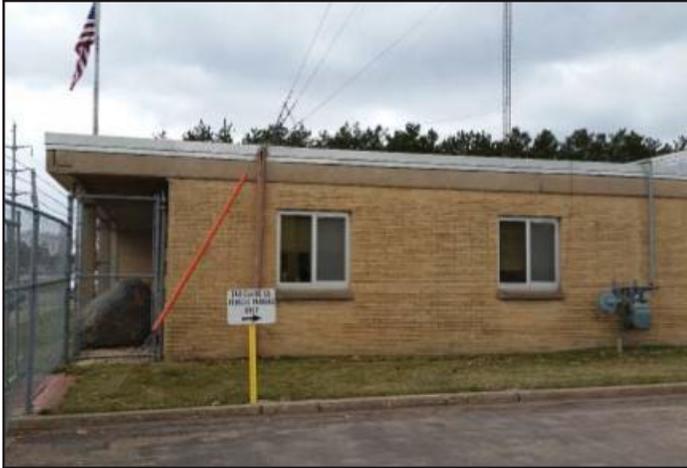
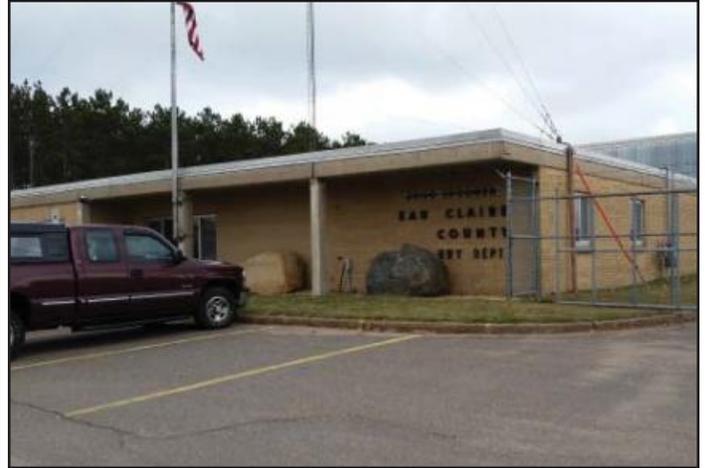
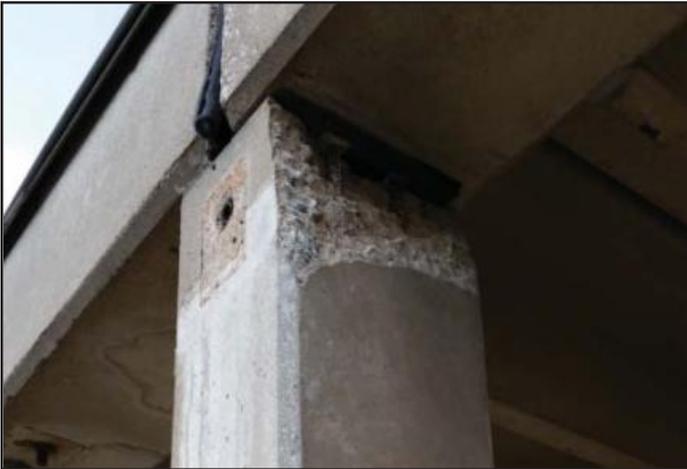
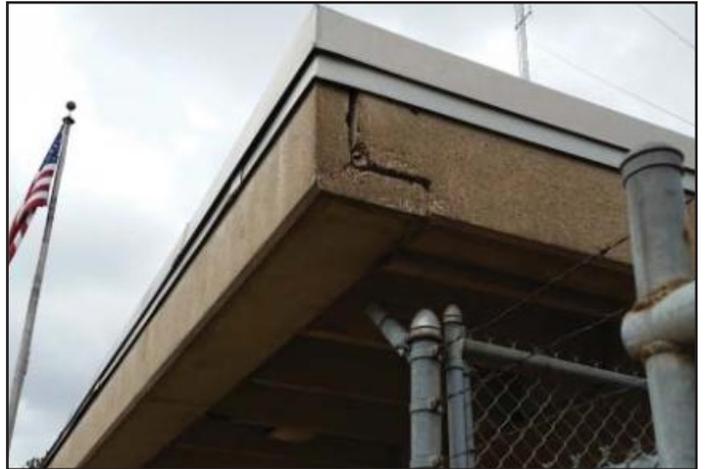
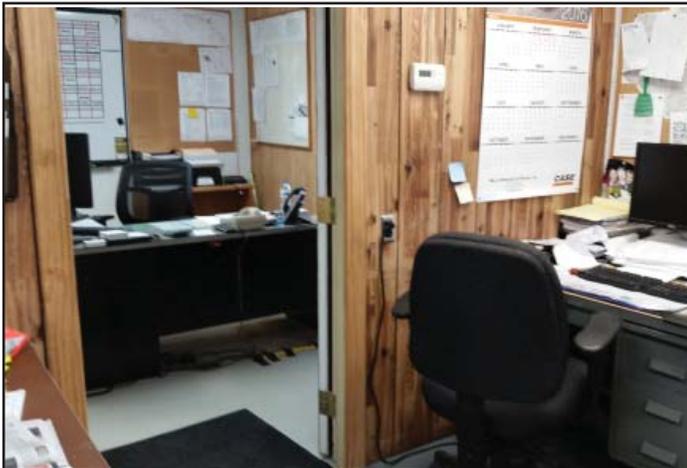
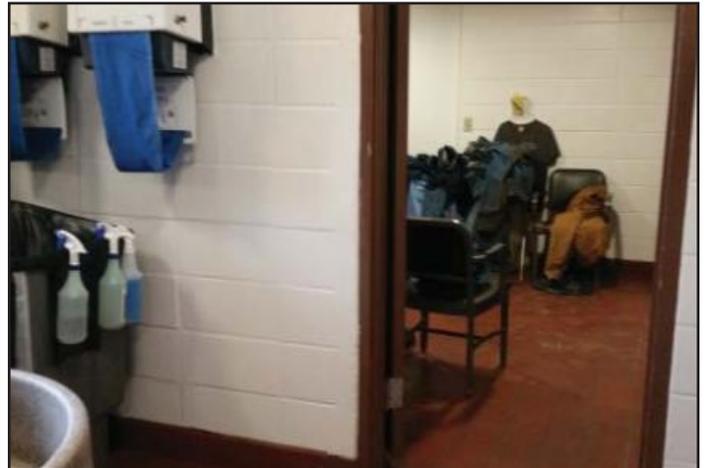
Administration Building #1

Condition Index: 43.7

Assessment: Poor condition, replace facility

The Office building at the Altoona Shop is in fair condition and is identified as needing rehabilitation and code compliance upgrades. The precast tee and column structure are showing signs of structural degradation. In particular the concrete columns are shearing right at the point where the tee's rest on them creating a precarious supports condition.

At the Administrative Offices three support posts on the south side of the building and three support posts in the repair garage have cracked concrete at the top bearing corners near the beam locations. Repair of these columns will be required to provide long term performance of the column/beam connection. Repair will consist of removal of cracked concrete, patching removal areas, with steel support brackets

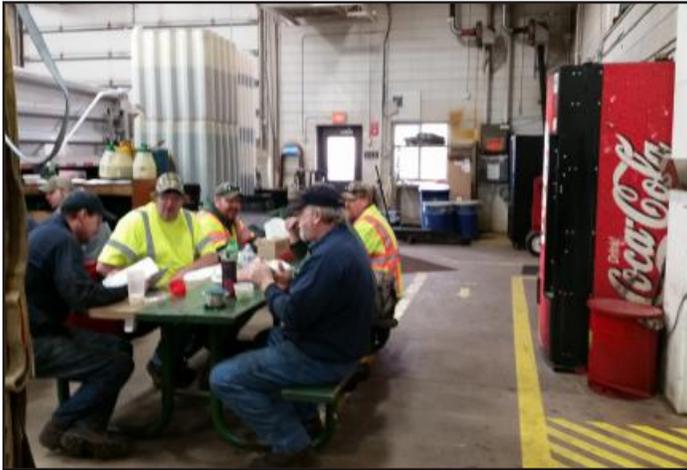
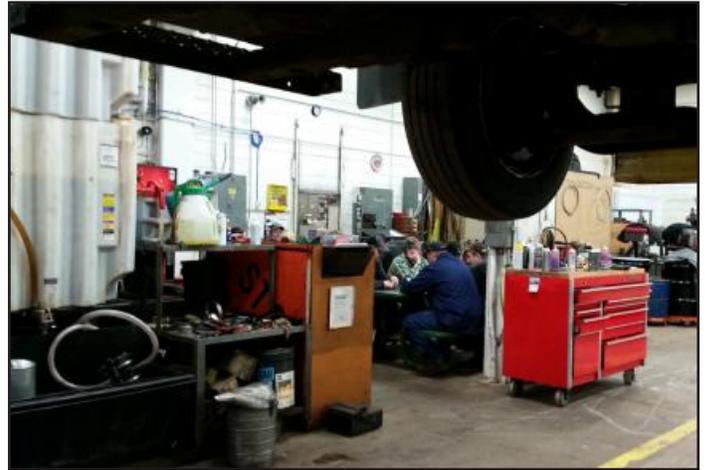
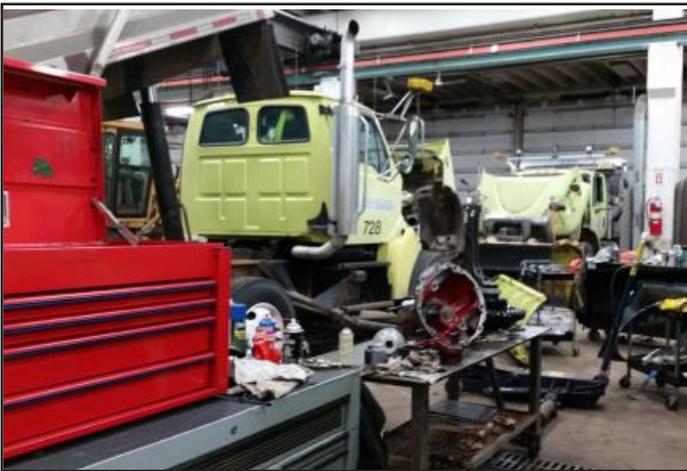
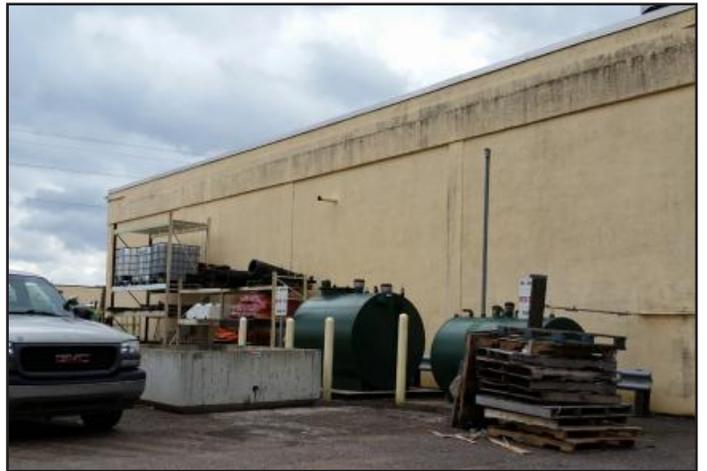
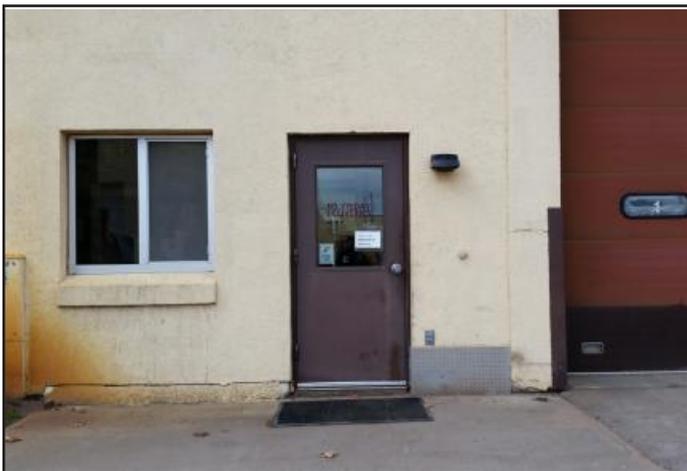
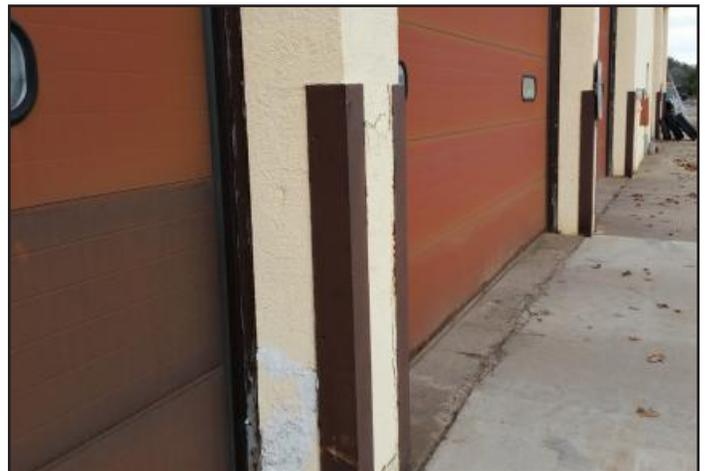
Repair Garage #1

Repair Garage Building #1

Condition Index: 42.7

Assessment: Poor condition

The Repair Garage at the Altoona Shop is in poor condition and is identified as needing moderate to major rehabilitation and modernization. The existing HVAC system requires significant overhaul and modernization to provide proper ventilation for the employees working in the repair garage. In addition, if the building is continued to be used for an extended time frame, the insulation of the existing roof and walls should be modernized to provide increased energy efficiency. Even with the repairs and upgrades listed below undertaken, the repair garage will not provide adequate repair bays and sizing along with equipment locations.

D Replace existing exterior light fixtures with energy efficient LED fixtures.

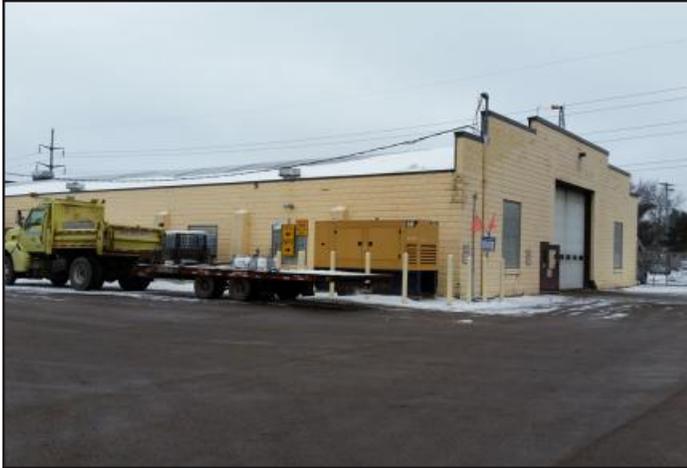
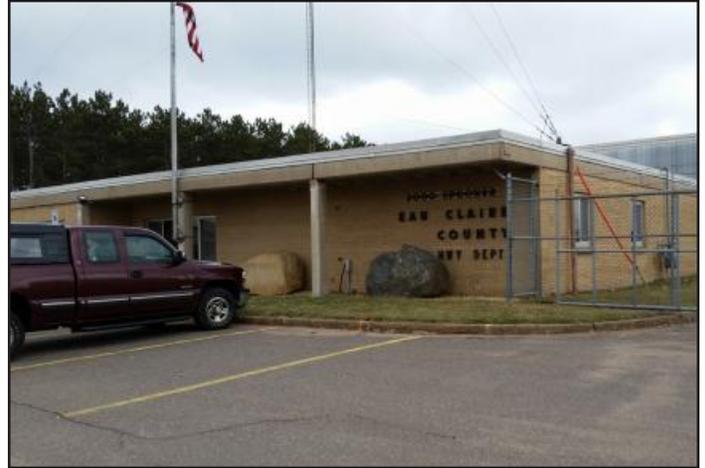
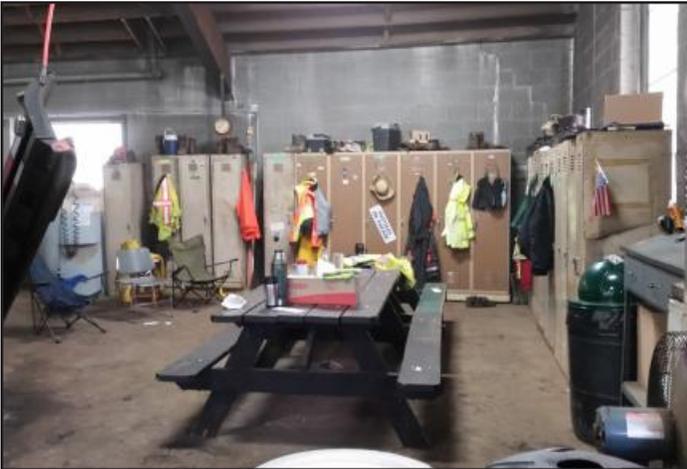
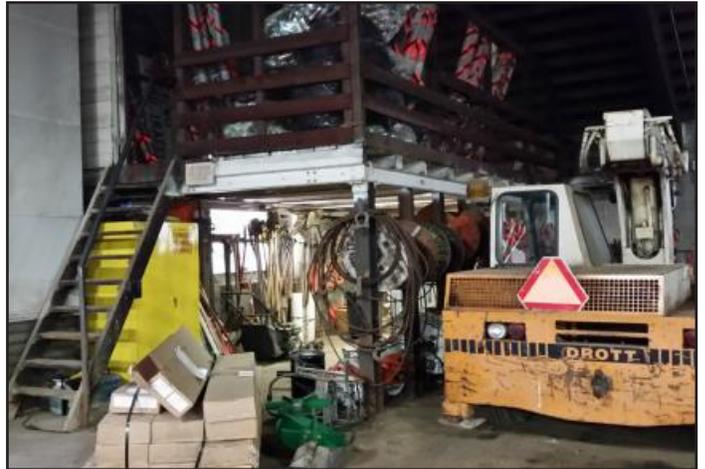
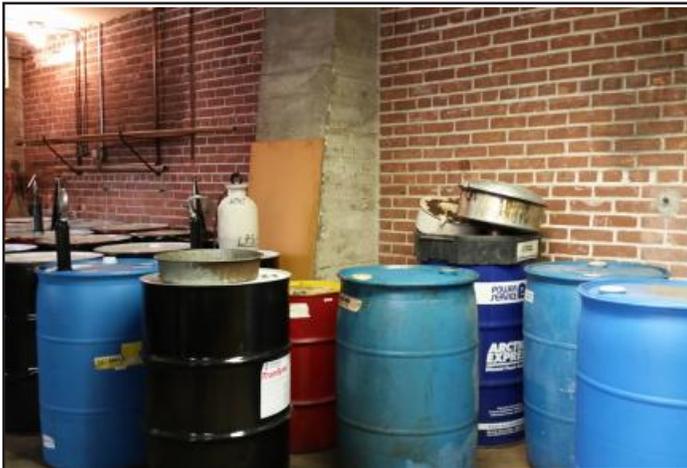
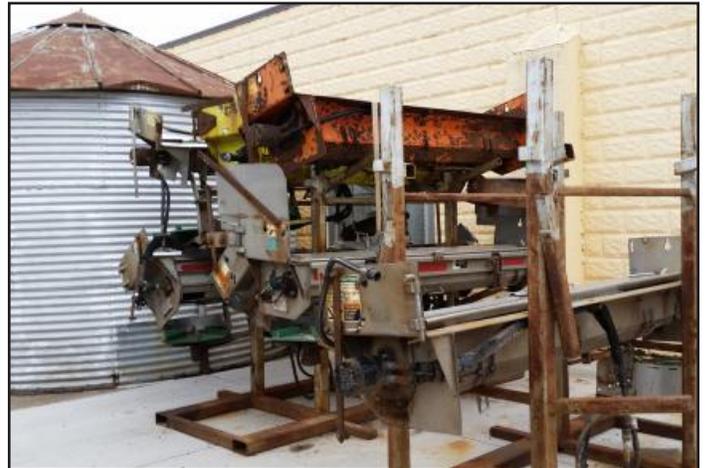
Parking Garage #2

Condition Index: 56.6

Assessment: Very Poor condition, replace the building

The tempered Truck Storage #2 Building is in obsolete condition and is identified as needing heavy rehabilitation and

modernization. While the wood glue-lam beams are in good condition, the load bearing wall and masonry between the piers are in very poor condition. There are numerous cracks through the masonry units that run both along course joints and straight through the block unit. The condition of the masonry concrete block is deteriorated in particular at the base and at the parapets. The paint finish is peeled away and is easily flicked off by hand.

- A Provide new concrete apron and drainage at each overhead door
- A Pave surrounding building with asphalt and stormwater system
- A Upgrade water, sanitary and sewer lines to Truck Wash
- D Replace existing exterior light fixtures with energy efficient LED fixtures.

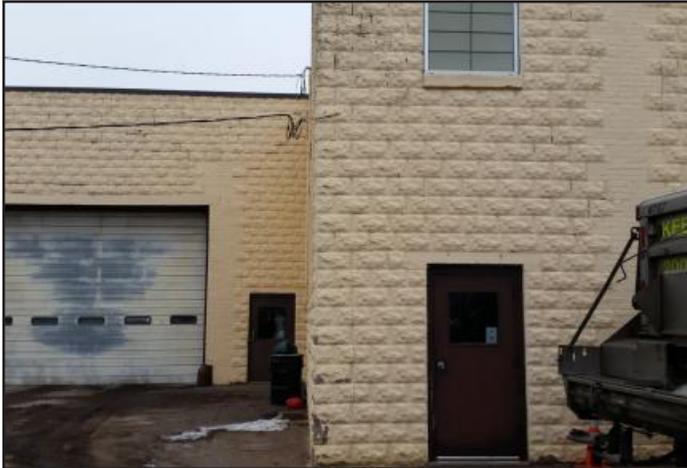
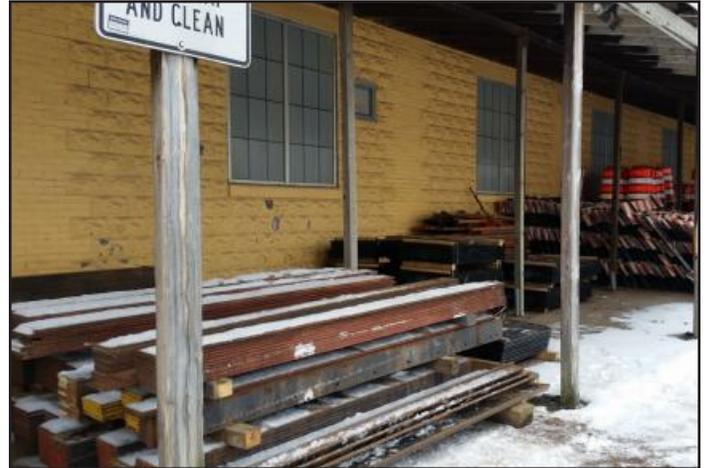
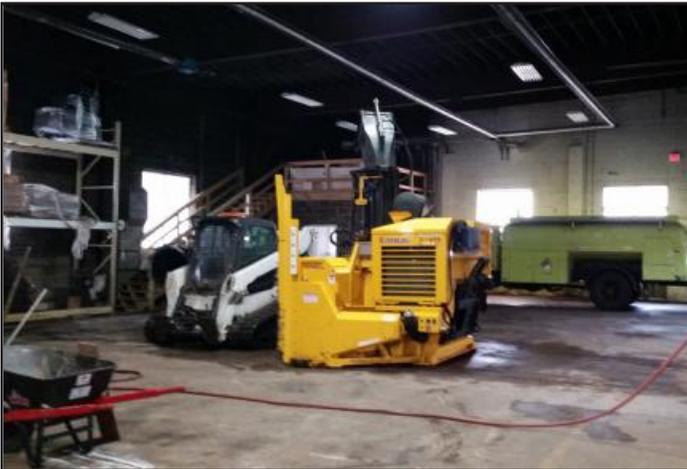
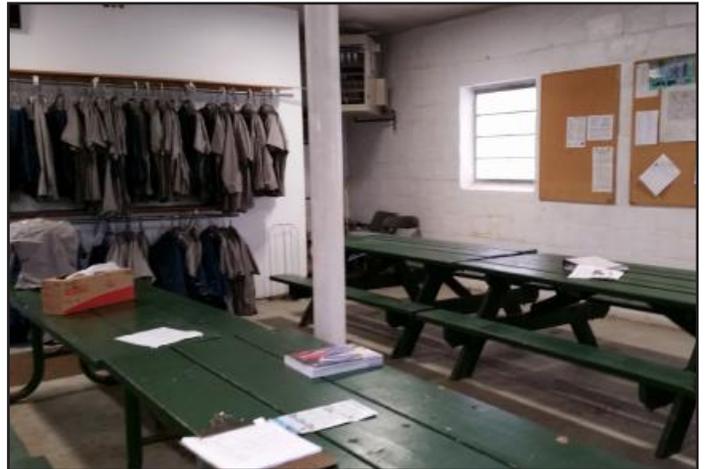
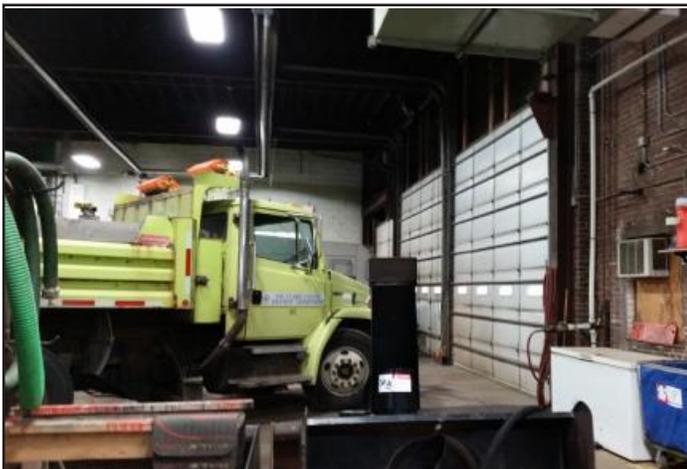
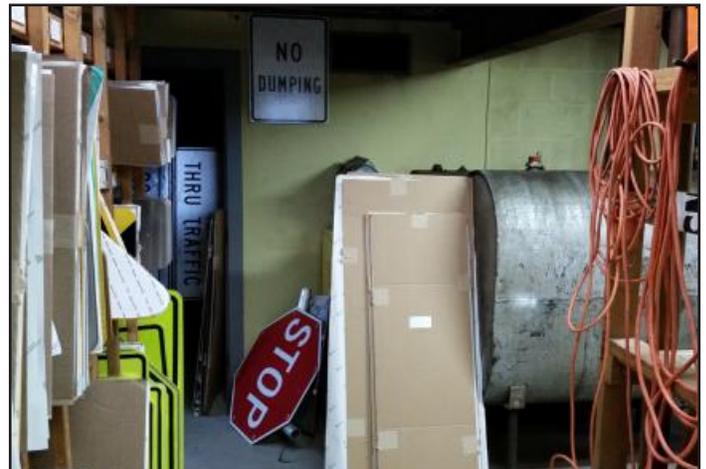
Condition Index: 73.5

Assessment: Poor condition, replace the building

The Warm Storage #3 Building is in obsolete condition and is identified as needing heavy rehabilitation and modernization. While the steel/wood joists are in good condition, the load bearing wall and masonry between the piers are in very poor condition. There are numerous cracks through the masonry units that run both along course joints and straight through the block unit. The condition of the masonry concrete block is deteriorated in particular at the base and at the parapets. The paint finish is peeled away and is easily flicked off by hand.

- A Pave over and provide stormwater management system
- D Replace existing exterior light fixtures with energy efficient LED fixtures.

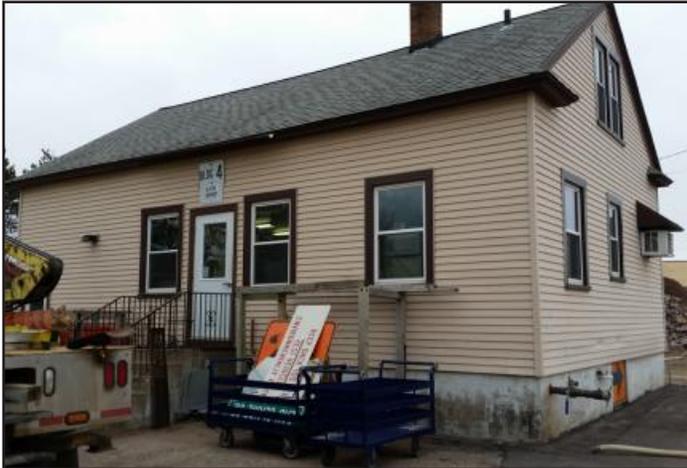
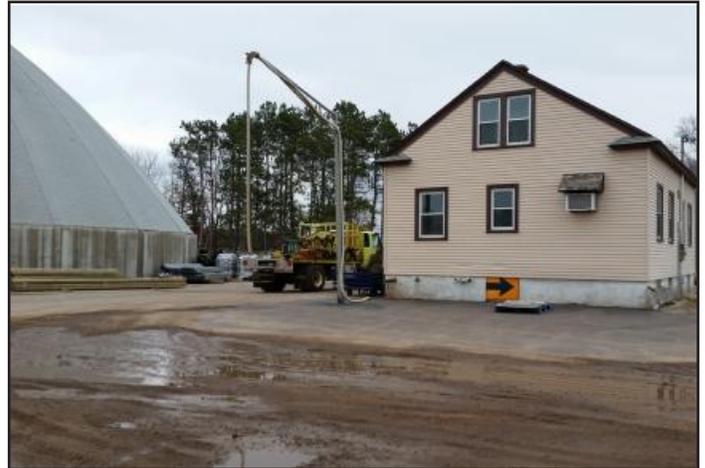
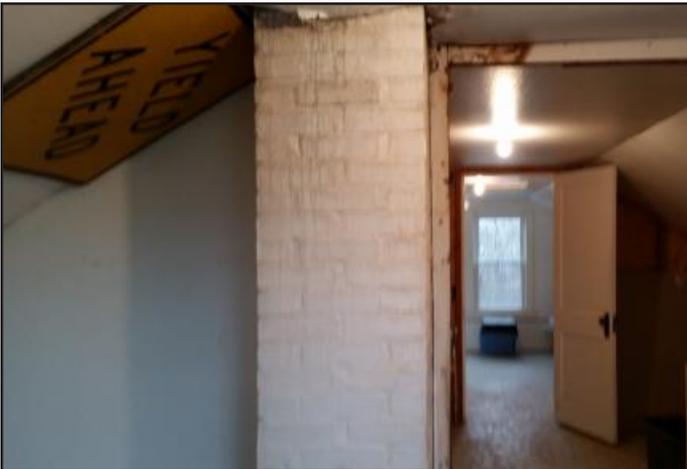
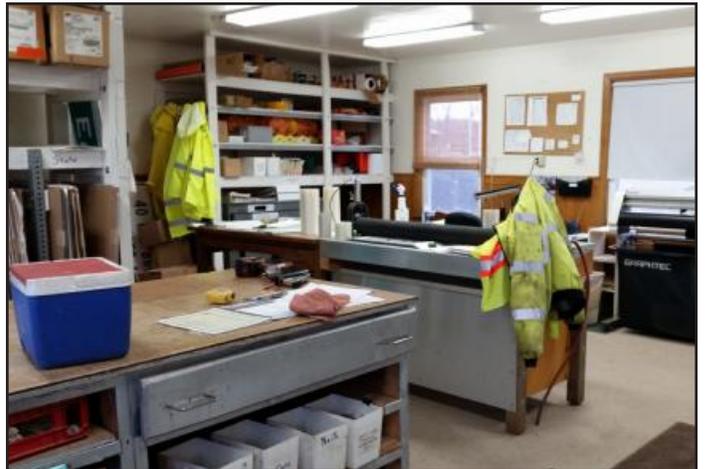
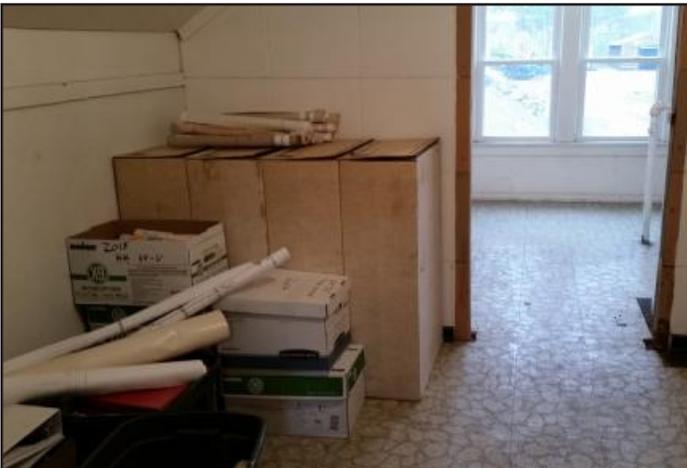
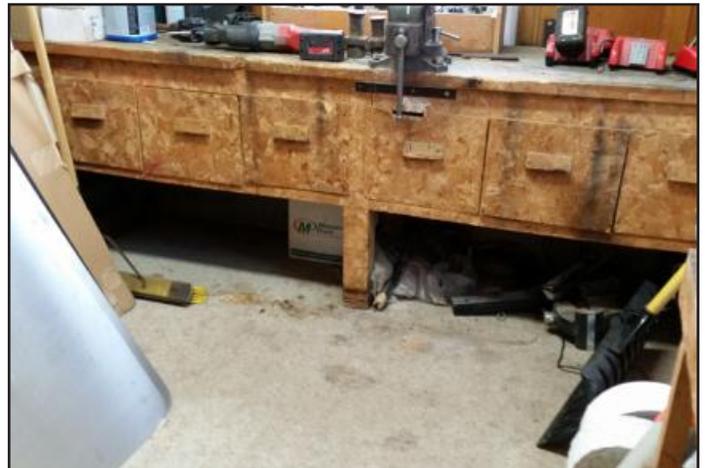
Sign Shop #4

Condition Index: 17.1

Assessment: Good to Fair Condition

B Provide engineered and structured stormwater system

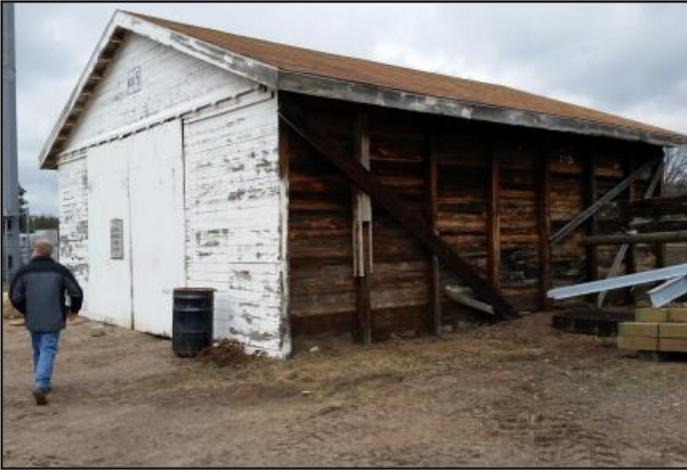
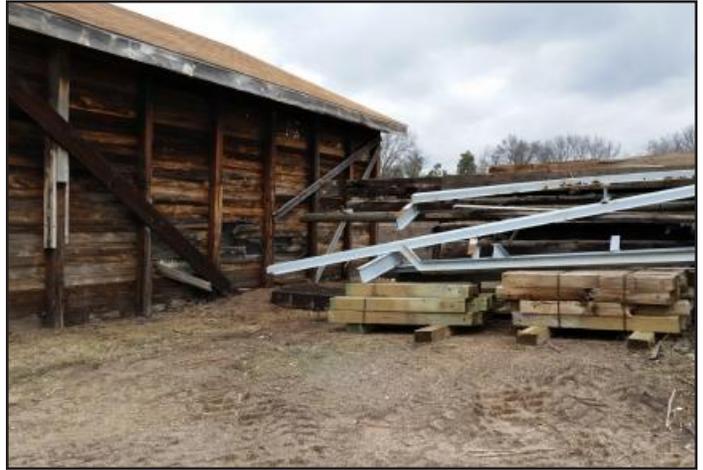
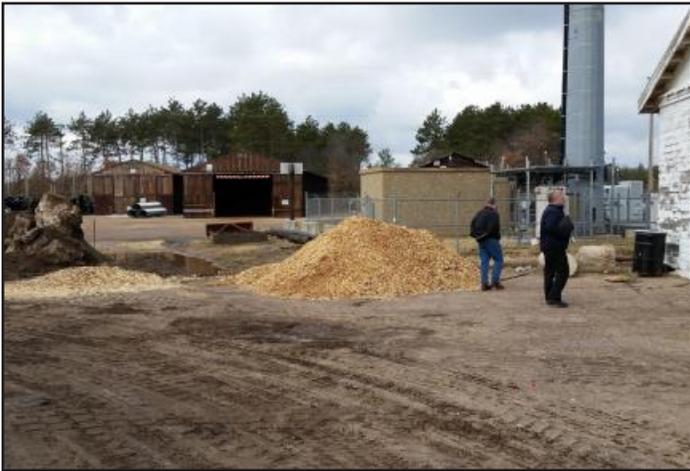
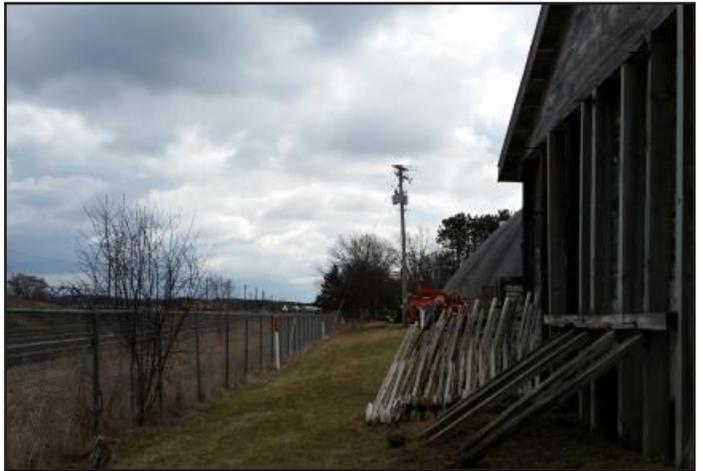
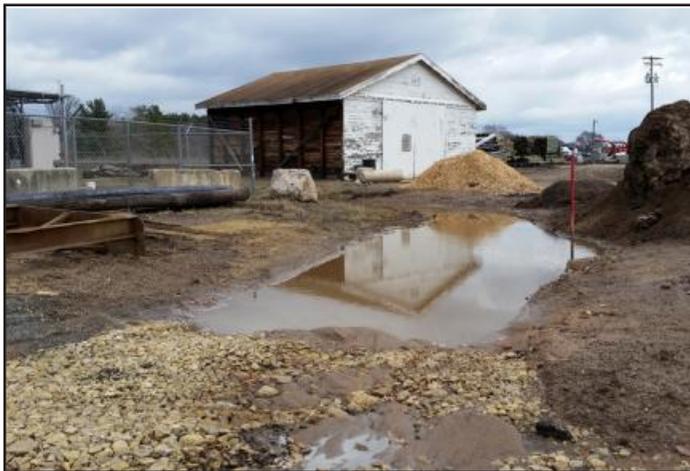
Storage Shed #5

Condition Index: 50.9

Assessment: Poor Condition, Replace building

This was originally constructed as a Salt Shed but being of modest size and deteriorating condition has been converted to being used for field storage items such as signs, barricades, palletized storage items and the like. There is no power, heating, ventilation provided. The building enclosure or heavy

wood is highly deteriorated and showing signs of pulling off from the frame. The enclosure also has many gaps and allows for wind and rain to enter and thus is providing minimal enclosure functions. Being a pole barn type structure it has neither foundation wall nor floor slab.

- B Provide exterior light fixtures
- B Pave area around building, provide structured apron at sliding door so heavy vehicles can be sustained.
- B Provide engineered and structured stormwater system
- B Relocate overhead power so out of the way of salt loading activities

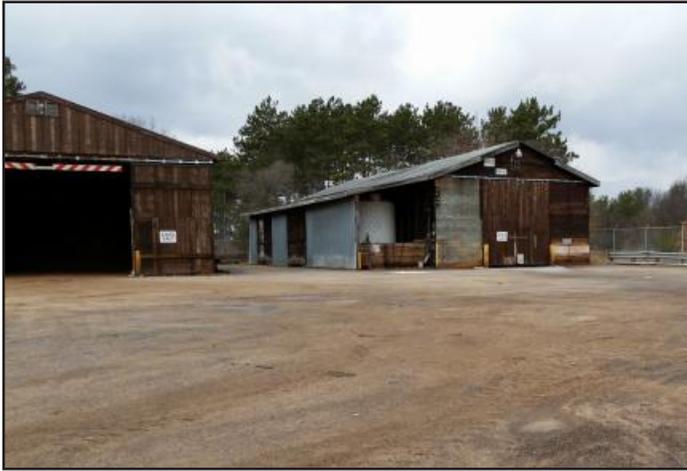
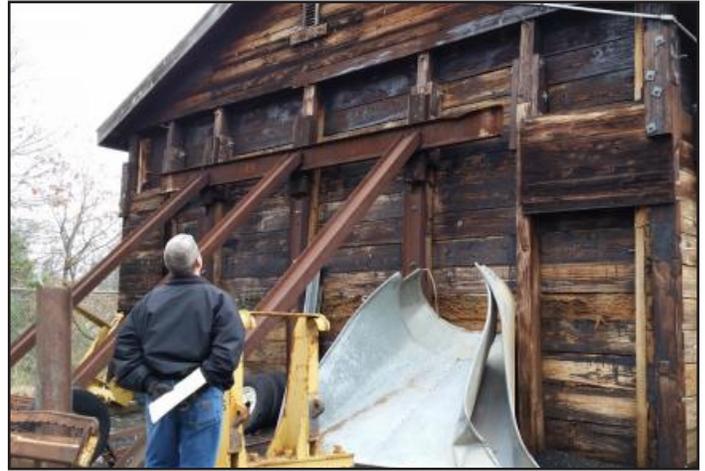
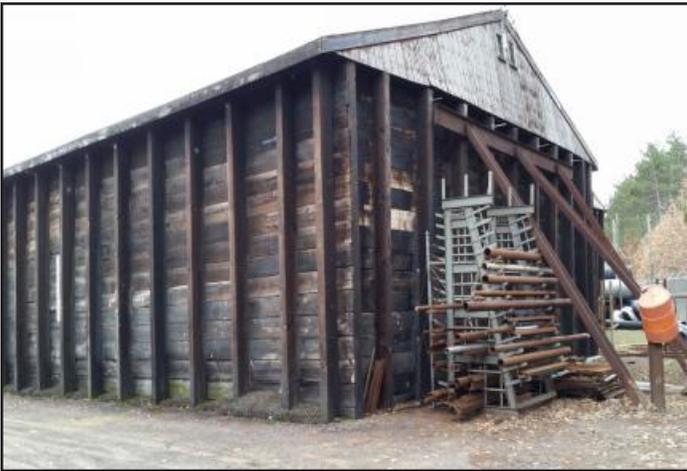
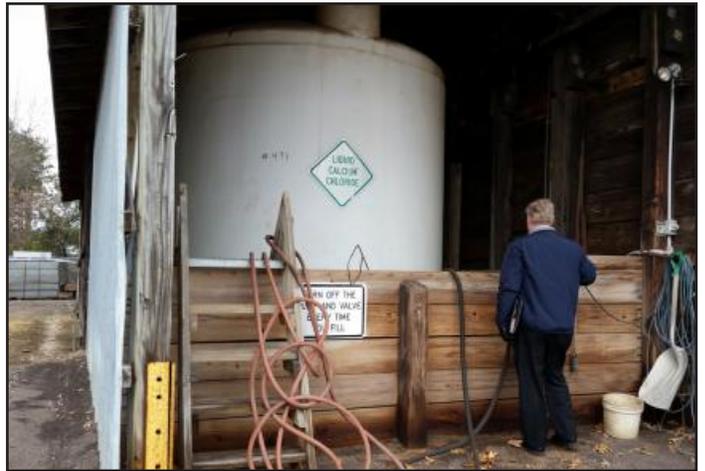
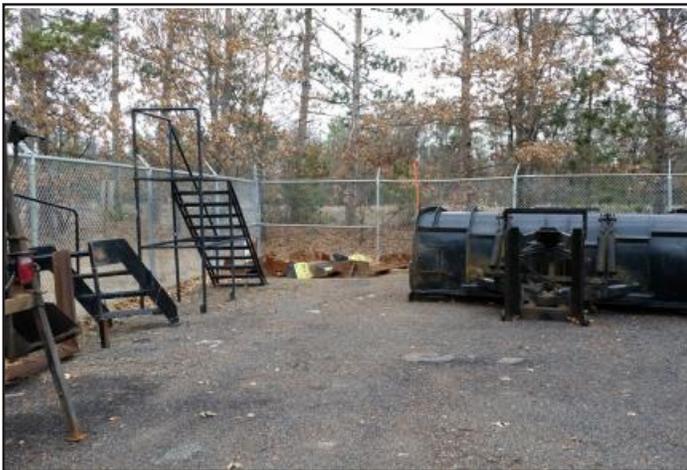
State Salt Shed #6

Condition Index: 50.9

Assessment: Poor Condition, Replace

The smaller of the two State Salt Sheds is of pole barn construction and has no foundation or floor slab. The wood siding is bulging outward some 10 inches in places and steel bracing has been put up to hold back the expansion forces. It is apparent that the structure cannot hold back the force of the salt tonnage stored here. This could be due to deterioration over time or that the building was under designed in the first place. Or it could be the County is stocking more salt in it beyond its posted capacity .The wood enclosure has many gaps and allows for wind and rain to enter and thus is providing minimal enclosure functions.

- B Provide exterior light fixtures
- B Pave area around building, provide structured apron at sliding door so heavy vehicles can be sustained.
- B Provide engineered and structured stormwater system
- B Relocate overhead power so out of the way of salt loading activities

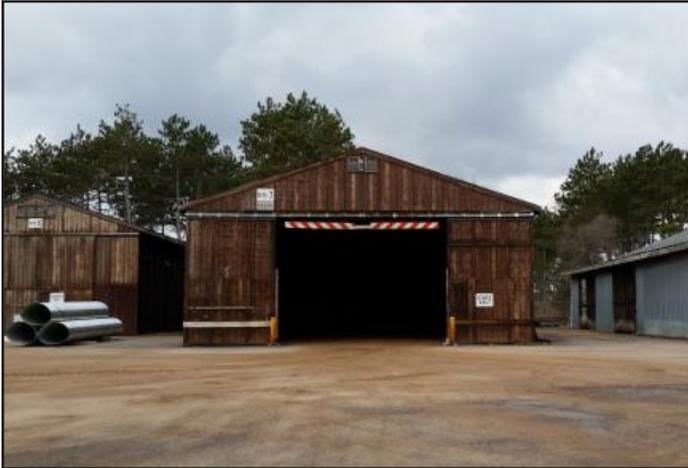
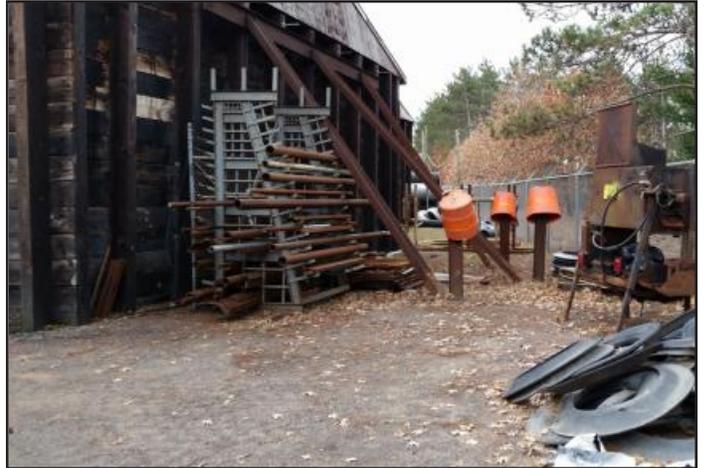
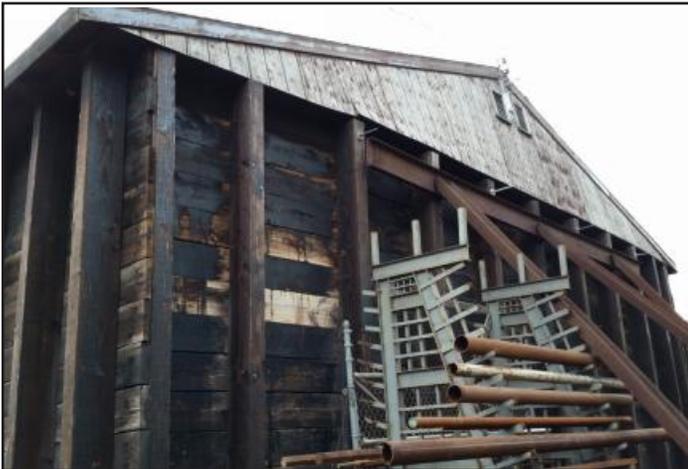
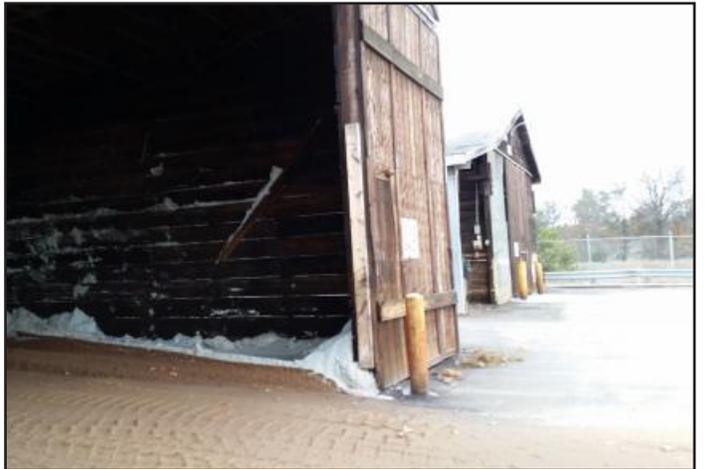
State Salt Shed #7

Condition Index: 50.9

Assessment: Poor Conditions, Replace Building

This is the larger of the Salt Sheds and it is of pole barn construction thus has no foundation or floor slab. The wood siding is bulging outward some 10 inches in places and steel bracing has been put up to hold back the expansion forces. It is apparent that the structure cannot hold back the force of the salt tonnage stored here. This could be due to deterioration over time

B Relocate overhead power so out of the way of salt loading activities

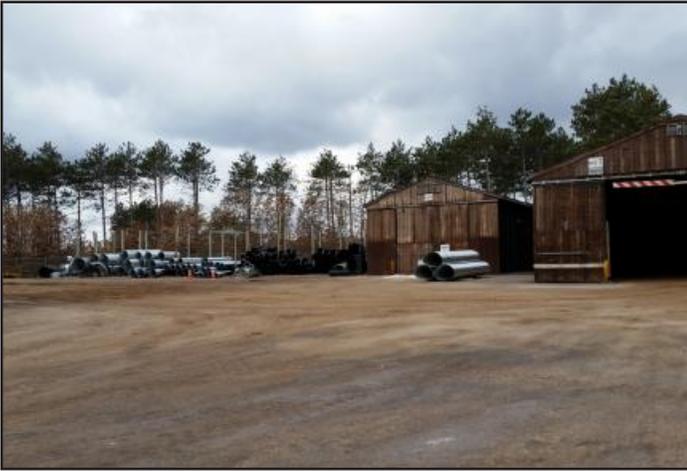
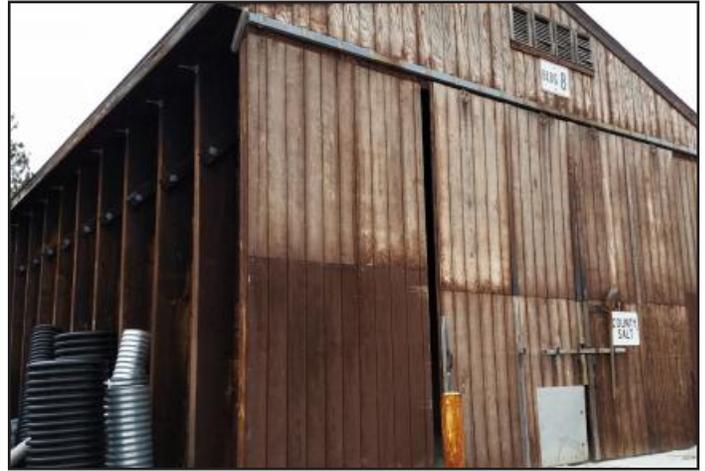
County Salt Shed #8

Condition Index: 50.9

- B Pave area around building, provide structured apron at overhead doors so heavy vehicles can be sustained.
- B Provide engineered and structured stormwater system
