EAU CLAIRE COUNTY Highway Department 2016 Space Needs Study

June 14, 2016
FINAL REPORT

4.3 Facility Condition Assessment Process & Audit

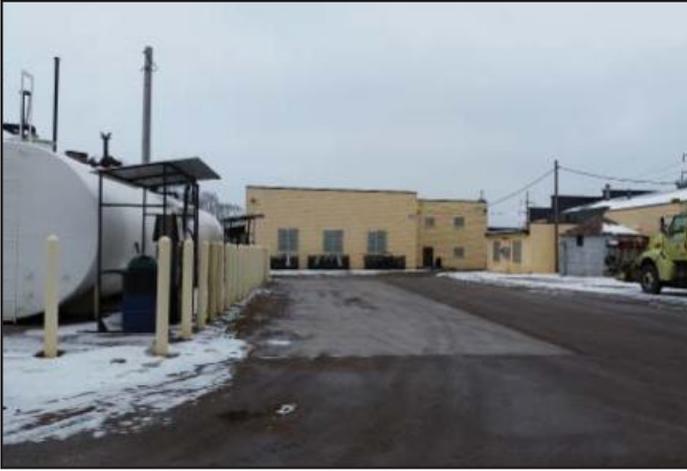
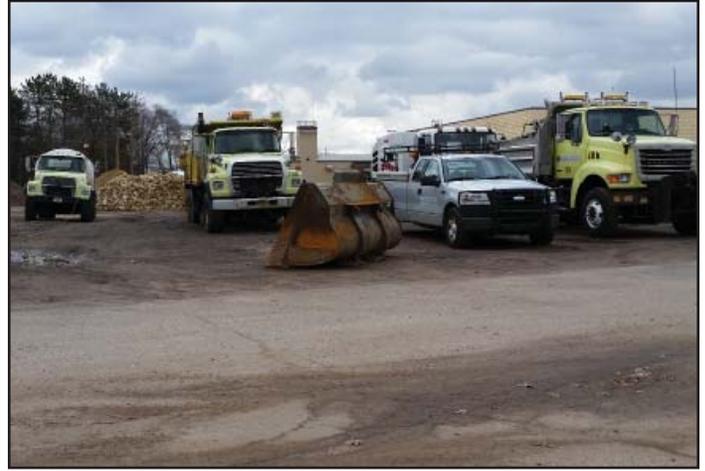
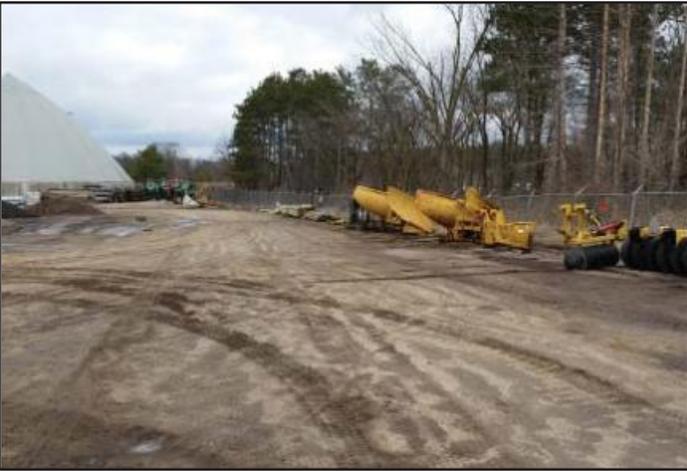
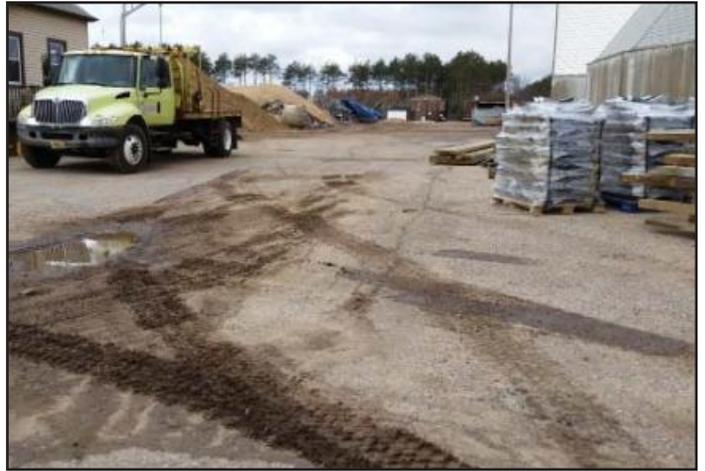
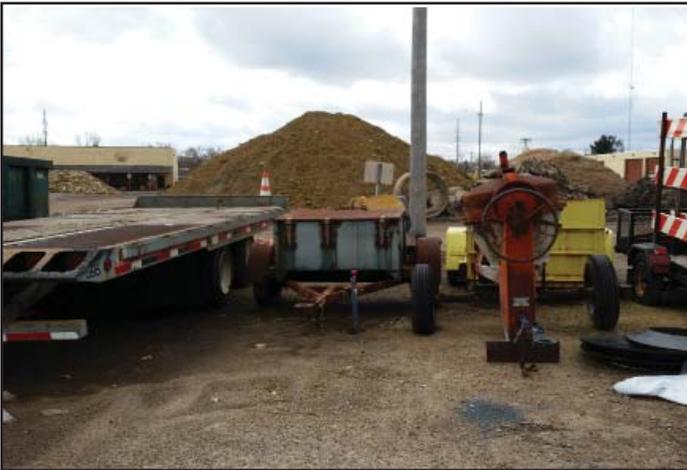
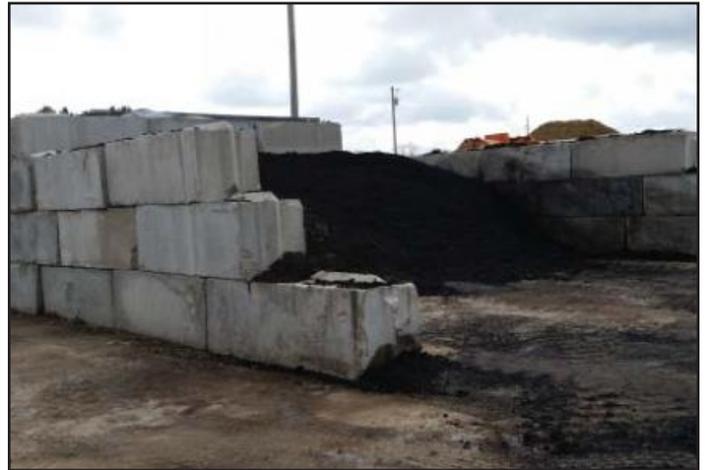
Existing Site

20. Landscaping. No ornamental or screening landscaping exists. Typically, when a site is redeveloped, cities will require some level of screening and tree planting.
